**Bellingham/Lake Whatcom Coal Mines
Bellingham No. 1 Coal Mine
Preliminary Assessment Report
Whatcom County, Washington
TDD: 03-01-0002**

Ecology and Environment, Inc.
Contract: 68-S0-01-01
October 2004

Superfund Technical Assessment and Response Team

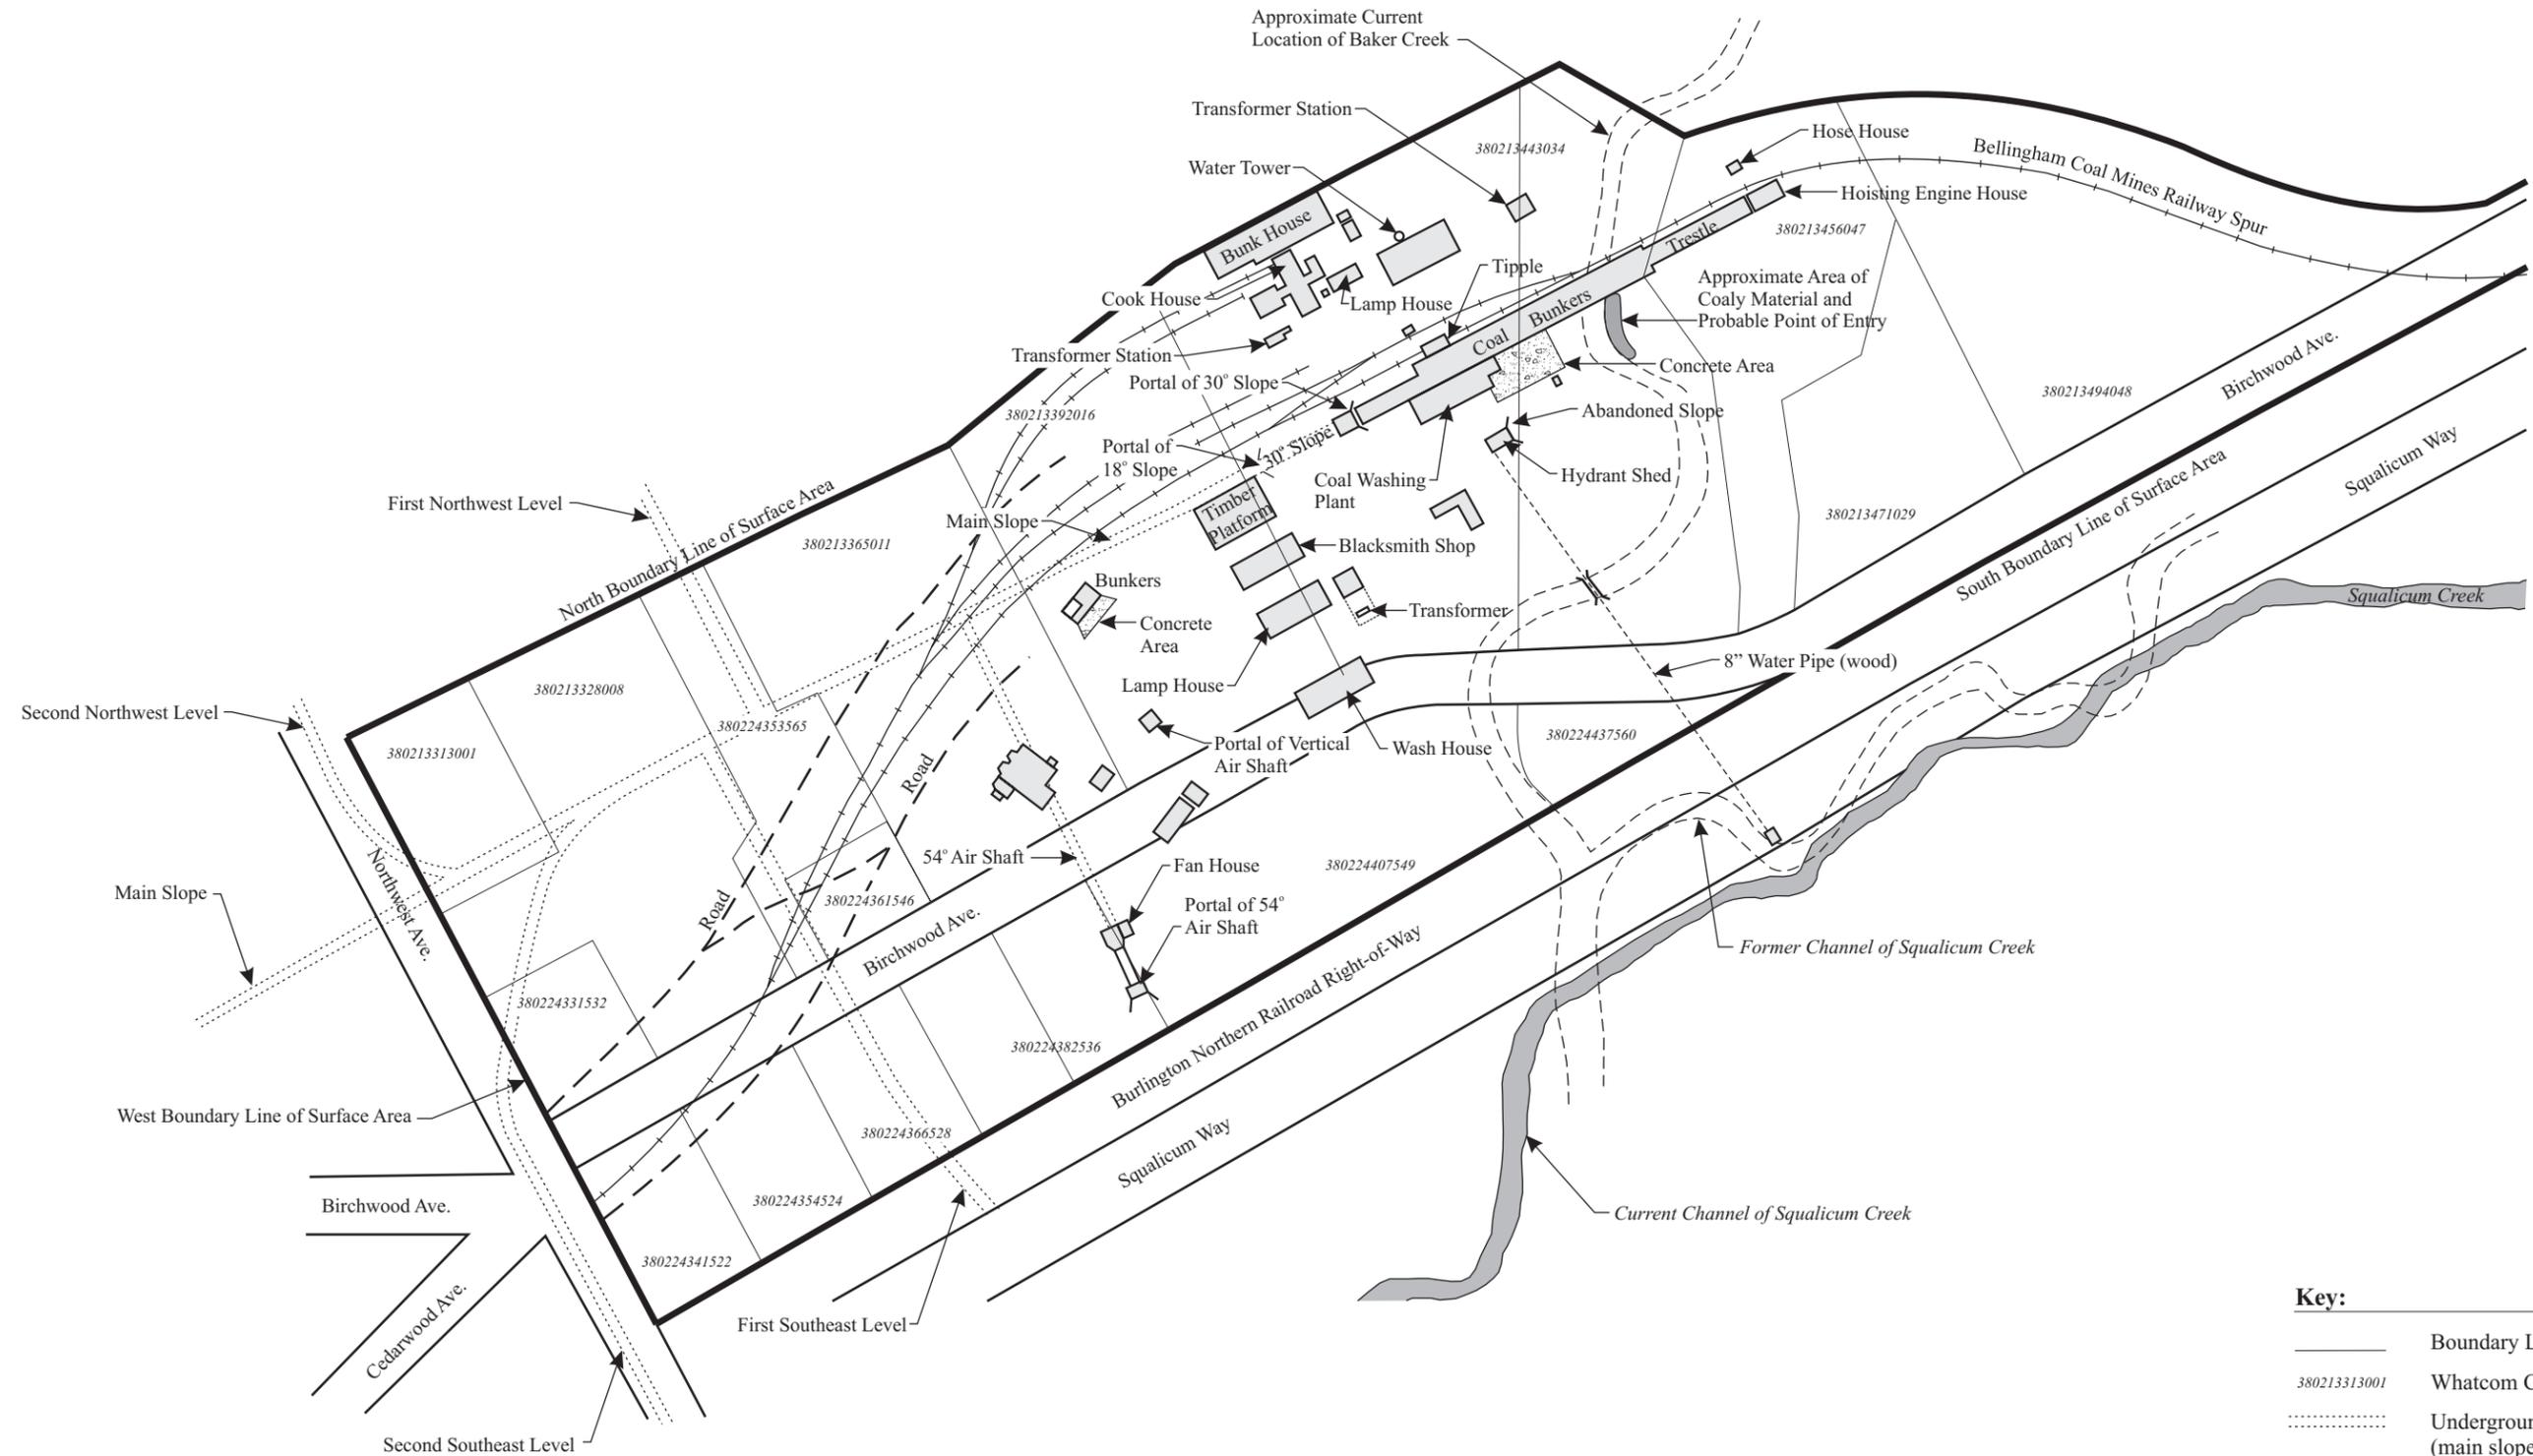
Figure 2-2
SURFACE FEATURES AND FACILITIES MAP
BELLINGHAM NO. 1 COAL MINE

Surface features that existed at the mine as of 1939 (BCM 1939) are illustrated in Figure 2-2. These features include:

- Portal of the 30° slope;
- Portal of the 18° slope;
- Trestle extending from the main slope;
- Hoisting engine house at the end of the trestle;
- Coal washing plant;

- Coal bunkers adjacent to the washing plant;
- Tipple;
- Portal of the abandoned slope;
- Bunkers and adjacent concrete area located southwest of the main slope portals;
- Portal of vertical air shaft;
- Portal of 54° air shaft;
- Fan house adjacent to 54° air shaft;
- Two transformer stations, located north and northeast of the main slope portals;
- Transformer located south of the of the main slope portals;
- Eight-inch water pipe spanning the distance between Squalicum Creek and the coal washing plant;
- Water tower; and
- Ancillary buildings, including a bunk house, cook house, lamp houses, hose house, wash house, blacksmith shop, hydrant shed, timber platform, and several unlabeled structures.

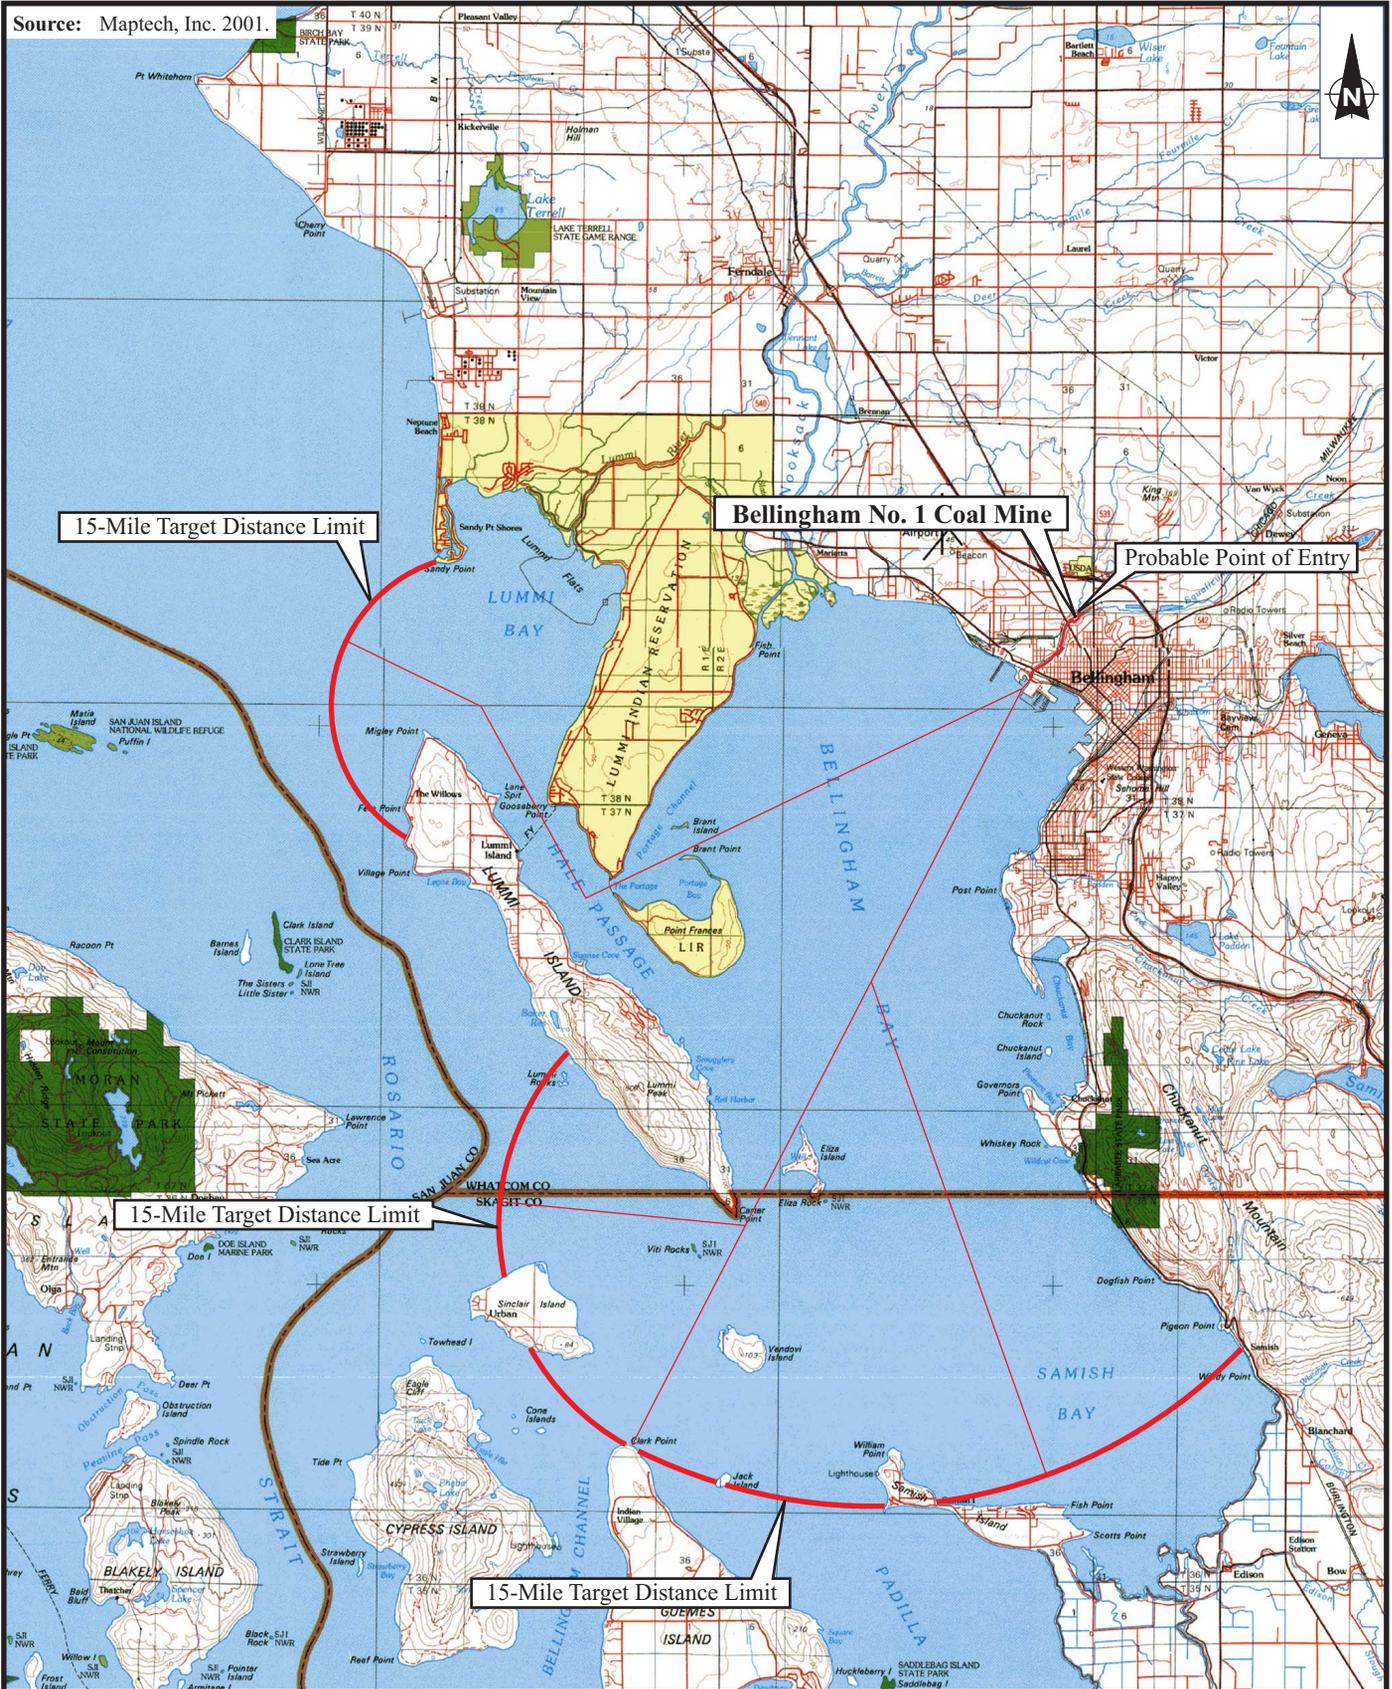
Figure 3-1
15-MILE MAP
BELLINGHAM NO. 1 COAL MINE

The surface water migration pathway target distance limit (TDL) begins at the probable point of entry (PPE) of surface water runoff from the site to a surface waterbody and extends downstream for 15 miles. The PPE at the Bellingham No. 1 Coal Mine is located along Baker Creek in the vicinity of the former coal bunkers where coaly material was observed along the stream bank during the January 29, 2004 START-2 site visit (Figures 2-2 and 3-1). From the PPE, Baker Creek flows generally southward approximately 800 feet downstream before merging with Squalicum Creek, which flows approximately 1.38 miles toward the southwest before emptying into Bellingham Bay. The surface water TDL extends radially from the mouth of Squalicum Creek another 13.47 miles into Bellingham Bay. Figure 3-1 depicts the surface water 15-mile TDL for Bellingham No. 1 Coal Mine.

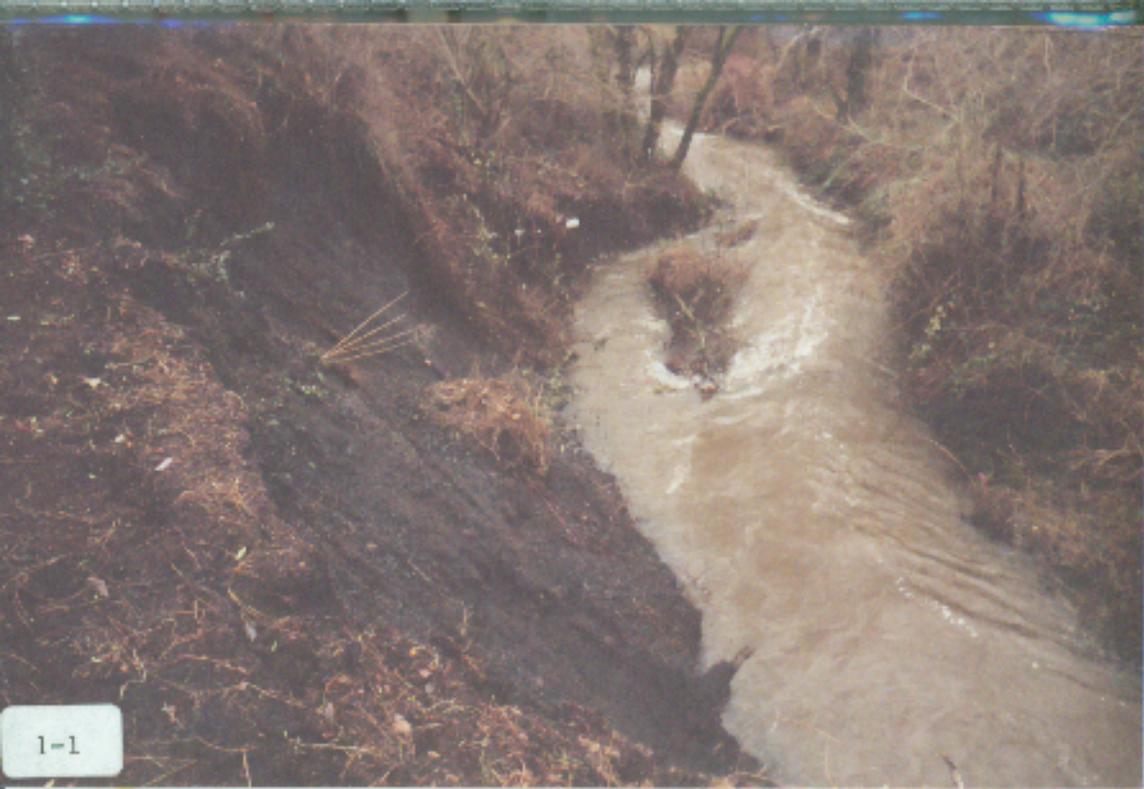
An exposed section of the east bank of Baker Creek, approximately 400 feet north of Birchwood Avenue, consisted of black, coaly material ranging up to cobble size (Photograph 1-1, Appendix C). The stream bank at this location inclines steeply from a flat shoulder approximately 20 feet down to Baker Creek. At the location where the coaly material was observed, the bank is devoid of vegetation and undercut by the stream, which was visually estimated to be flowing at 30 cubic feet per second at the time of the site visit. It was not possible to determine the extent or volume of the coaly material because the steep embankment and thick brush limited access, and dense vegetation and landscaping and/or pavement obscure the makeup of the substrate. The START-2 estimates that the coaly material exists over an area of at least 1,000 square feet. Coal fragments were observed along the bed of Baker Creek downstream of the undercut bank (Photograph 1-2, Appendix C). It was not possible to access Squalicum Creek during the site visit. START-2 also observed a concrete pedestal approximately 10 feet by 3 feet by 3 feet high on the east bank of Baker Creek approximately 50 feet north of the undercut coaly bank. Coal fragments were also noted scattered on the surface of soil along the northern property line (fence line) of Whatcom County parcel no. 380213365011 (Whatcom County 2003), as illustrated in Photograph 1-1 (Appendix C).
